Re: **Report of Field Observation – FY00 – First Quarter (FY00-1Q)
Lees Lane Superfund Site, Jefferson County, Kentucky,
Administrative Order on Consent. USEPA Docket No-91-32-C**

**REPORT OF FIELD OBSERVATION
LEE'S LANE LANDFILL SITE, LOUISVILLE, KENTUCKY**

Observation Report No.: FY00-1stQ

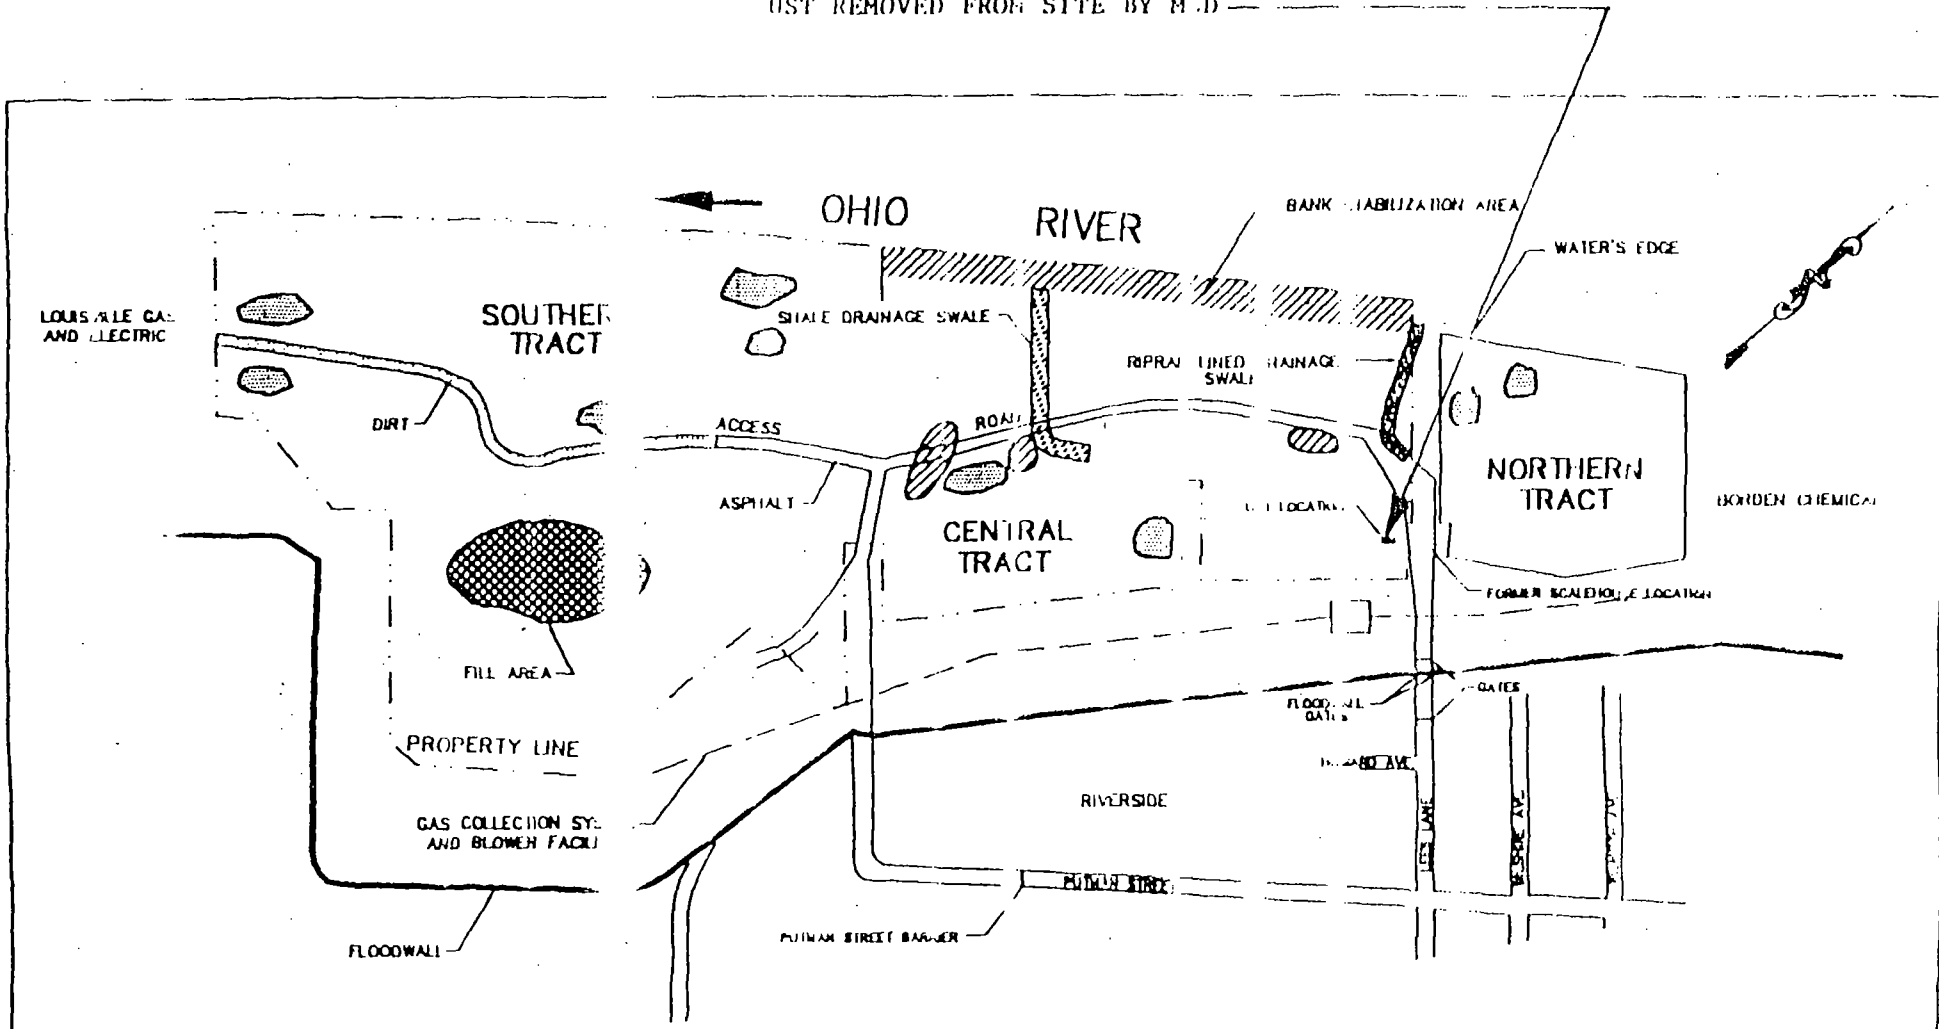
ARCS / LEE'S LANE L
LOUISVILLE, KENTU

UST REMOVED FROM SITE BY MCD

DRAWING NOT TO SCALE
SOURCE: RESOURCES APPLICATIONS, INC.
